Troubleshooting: HP LaserJet III Malfunction „50 SERVICE“

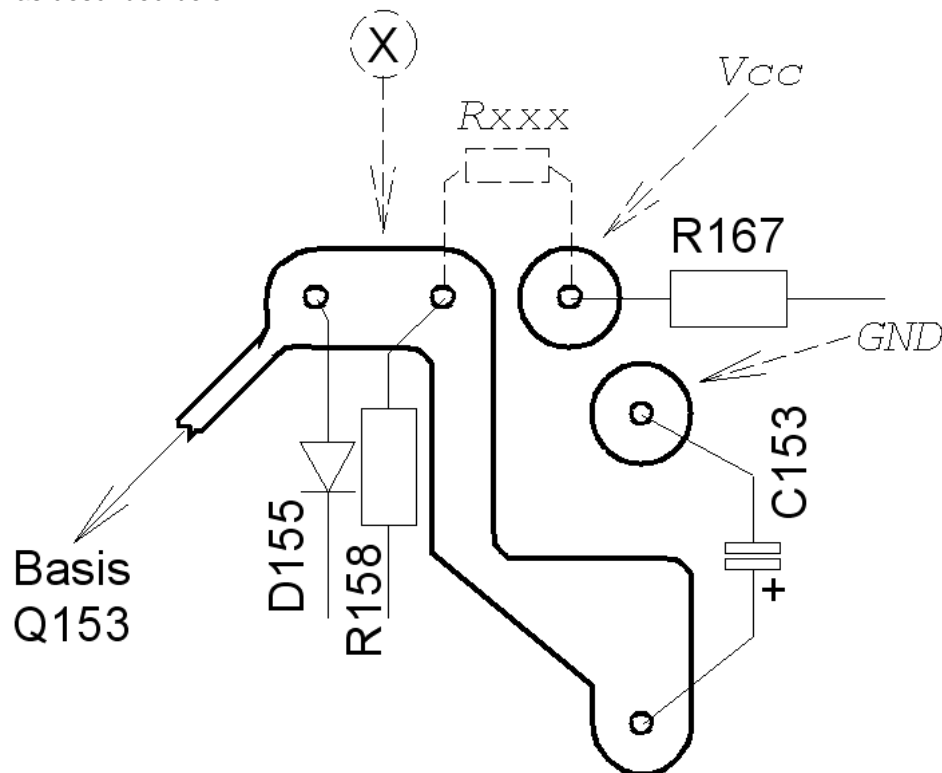
- 1.) Remove the following four circuits from the board (carefully soldering!):
Capacitor **C153** (22 μ F/25V) Resistor **R158** (560k) Diode **D155** Transistor **Q153** (2SC1815)
- 2.) After soldering let the PCB cool down to room temperature!
- 3.) Use an ohmmeter (2M range) and measure the resistance (leakage current) from the track which was connecting these four circuits (at base of Q153) to Vcc (pin 10 of connector J151 or R167).
- 4.) There should be absolutely high impedance as the track is not longer connected to any circuit. But if there is a resistance of less than 2M (down to 170k) measured, then there is a pseudo “resistor” *Rxxx* arisen within the PCB base material between the feedthrough holes of R158 and R167.
- 5.) Repair PCB as described below:

Drawing 1: Solder side of RG1-1438 before repair (with pseudo „resistor“ Rxxx)

- Extensive heat generated by R167 or caused by low power fan of the first generation.
- Too small distance of the feedthrough holes of R158 and R167.
- Aging of the cheap PCB base material.
- The design of the safety circuit around R157, R158 and C153 which is relatively high impedance.

- 1.) Cut the track at mark (X) in the middle between the feedthrough holes of D155 and R158.
- 2.) Do a control measurement (cold PCB) from the remaining track at base of Q153 to Vcc. There should be no measurable resistance (high impedance).

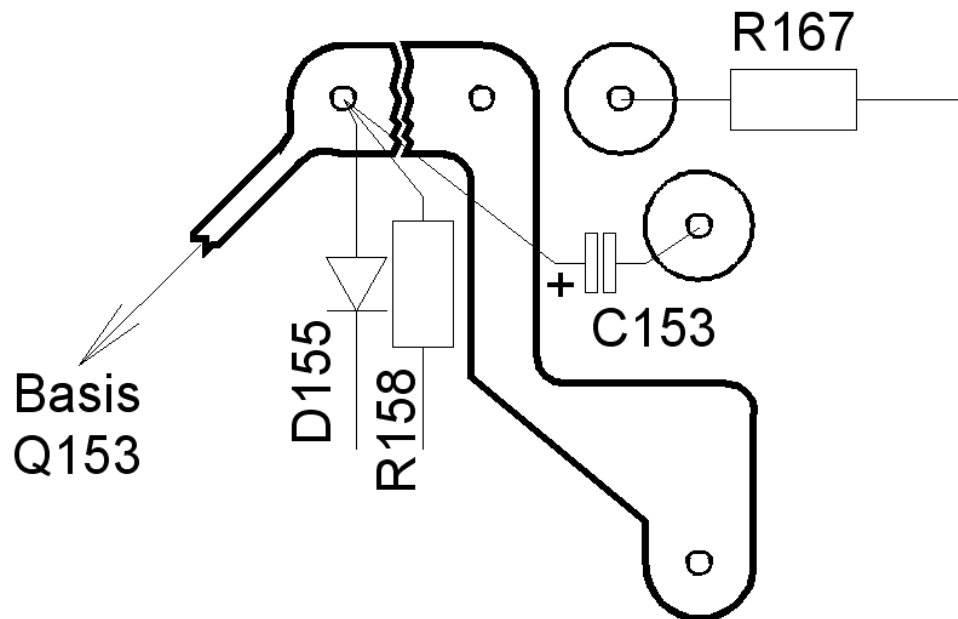
Drawing 2: Solder side of RG1-1438 after repair (circuit wiring on the circuit side of PCB)

- 3.) Solder in the Diode **D155** and the Transistor **Q153** (2SC1815) at its original positions.
- 4.) Solder in the ,lower' leg of resistor **R158** (560k) at its original position. The 'upper' leg of R158 should be soldered directly on the 'upper' leg of D155 (circuit side of the PCB).

- 5.) Solder in the (-) leg of capacitor **C153** (22µF/25V) at its original position. The (+) leg of C153 should be soldered directly on the 'upper' leg of D155 (circuit side of the PCB).
